CASE REPORT

Post and Core Restoration of Endodontically Treated Teeth - A Case Series

¹Post graduate student, ²Professor and Principal, ³Professor and Head of the Department, Department of Prosthodontics and Crown and Bridge, Dr. R Ahmed Dental College and Hospital, Kolkata.

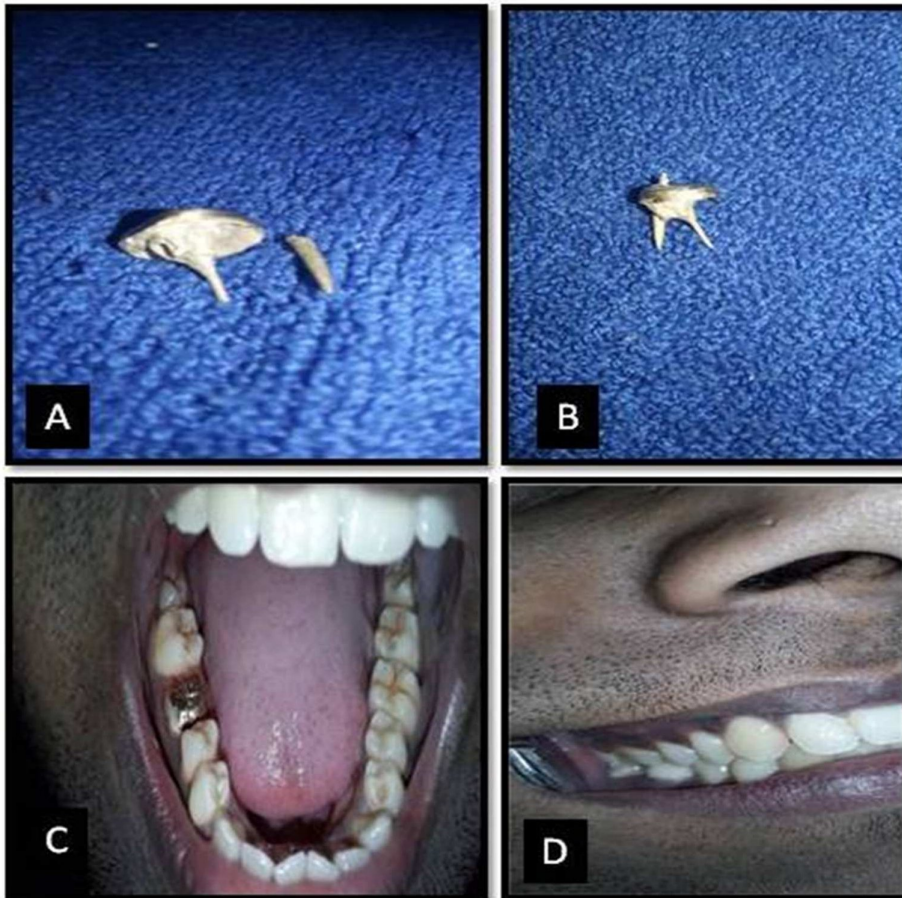
Fig 2: A & B- Custom split cast metal post and core, C- Post and core placed in the pre- pared tooth, D- Tooth restored with PFM crown.

A 27 year old male was referred to the Department of Prosthodontics and Crown & Bridge after endodontic treatment of tooth no 46. As the tooth was grossly decayed and roots were divergent a split cast metal post and core was planned. Post space was prepared in the mesio-buccal and distal canal (Fig 1A) with piezo reamer leaving around 5mm of Gutta percha inside the canal. A metal wire of approximate post space length was taken and bent at the exit. Light body addition silicone impression material was injected inside the canal with a syringe and the metal wire was placed inside the canal and moved up and down. Heavy body addition silicone impression material was loaded simultaneously in the impression tray and an impression was made (Fig 1B). After completion of the casting process the cast metal posts were adjusted to fit in the canal space and cementation was done using resin cements (Fig 2A & B). The tooth was then restored with a PFM crown (Fig 2C & D).

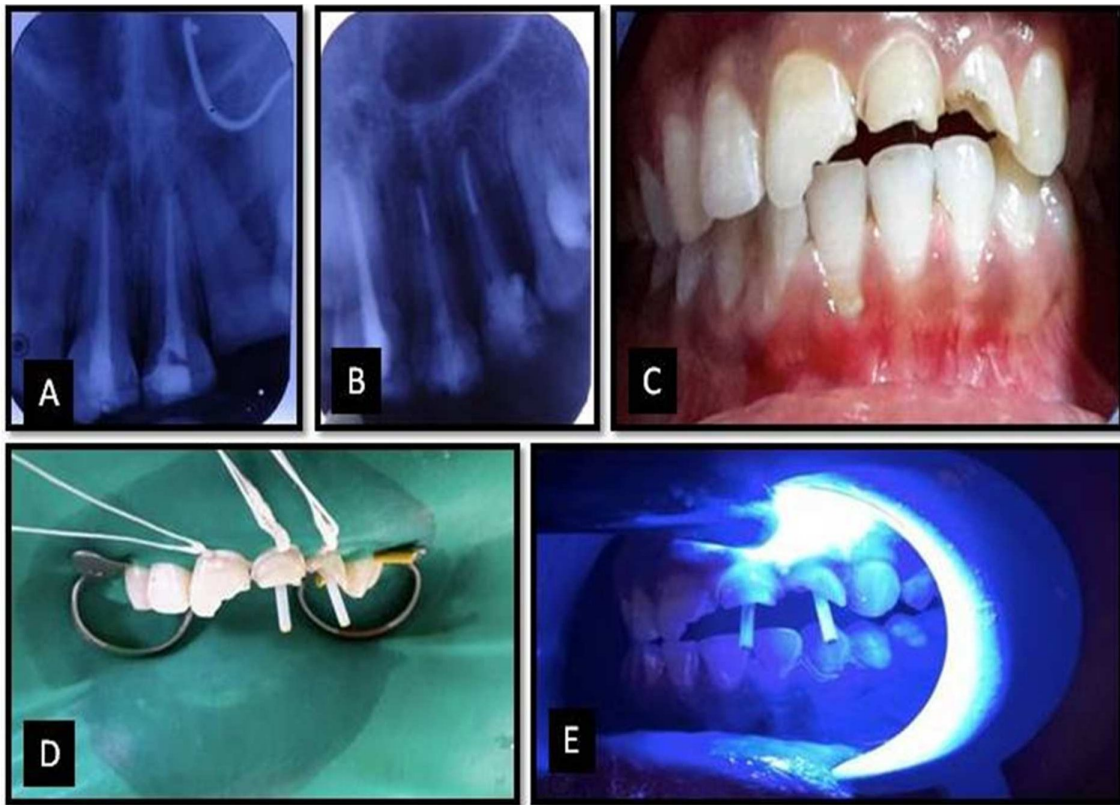
Fig 3: A- Preoperative IOPA, B- IOPA after post space preparation, C- Ferrule prepared, D- Glass fiber posts placed, E- Fiber posts cemented with dual cure resin cement.

A girl of 24 year old was referred to the Department of Prosthodontics and Crown and Bridge after getting treated endodontically in maxillary right central, left central and lateral incisor with loss of tooth structure due to trauma. Pre operative radiograph showed good apical seal of the canals (Fig 3A). As more than half of the tooth structure was lost and adequate thickness of wall was not present anterior esthetic fiber post core restoration was

planned for both the left central and lateral incisor. Maxillary right central incisor was built up with composite core. After removal of the thin unsupported tooth structure post space was prepared for left central and lateral incisors leaving behind 5mm of gutta percha in the canal (Fig 3B & C). Glass fiber post as placed in prepared post space (Fig 3D & E). Core resin material was used and core build up was done (Fig 4A). Finally all the teeth were prepared for porcelain fused to metal crown and restored (Fig 4B & C).

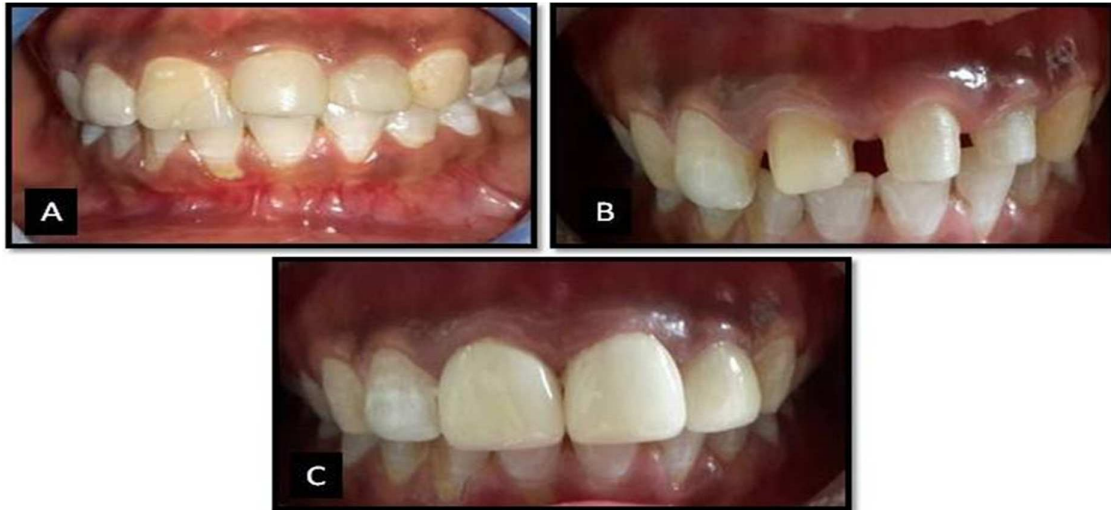
Fig 4: A- Core build up done with resin, B- Tooth preparation completed for crown fabrication, C- Teeth restored with PFM crown.

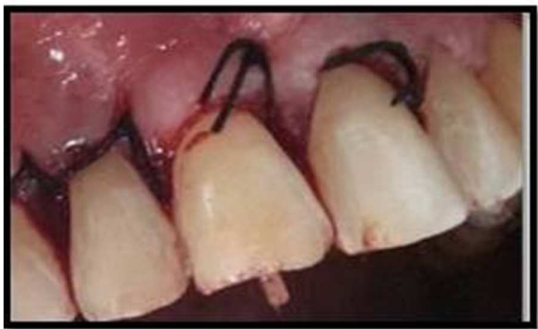
Fig 6: Suture placed and flap closed.

removed (Fig 5C & D, Fig 6). Immediate single sitting root canal treatment was done and a glass fiber post was placed inside the prepared canal. The fractured fragment was repositioned with flowable composite resin and flap closed. Proper aesthetics and function was achieved.
